# Tenara® UV Resistance Chart

## Effects of UV Sunlight Exposure

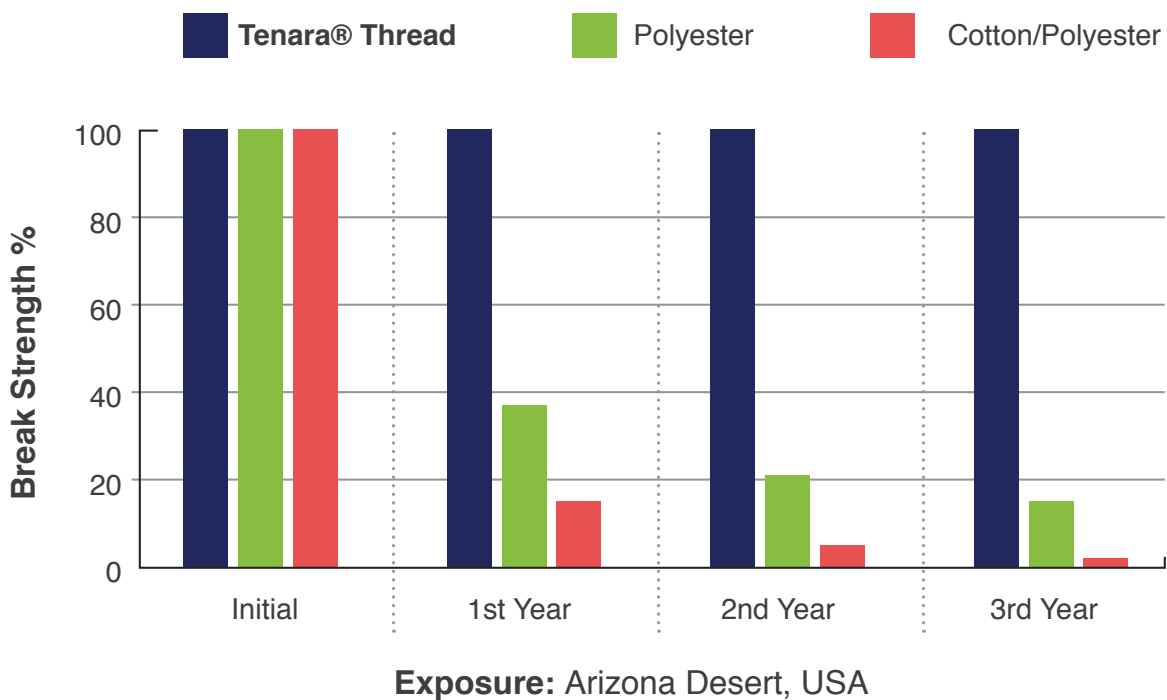
Tenara thread samples were tested alongside polyester and cotton/polyester blend threads. The thread was exposed to Arizona Desert sunlight for 3 years and the break strength of each thread type was recorded after each year. The results show that Tenara thread has unparalleled UV resistance and that after 3 years of sun exposure was still at 100% break strength.
